Programming and Feasibility Report

# CCFP NATURE CENTER

Homer, IL  
BE Project #24133  
April 30, 2025

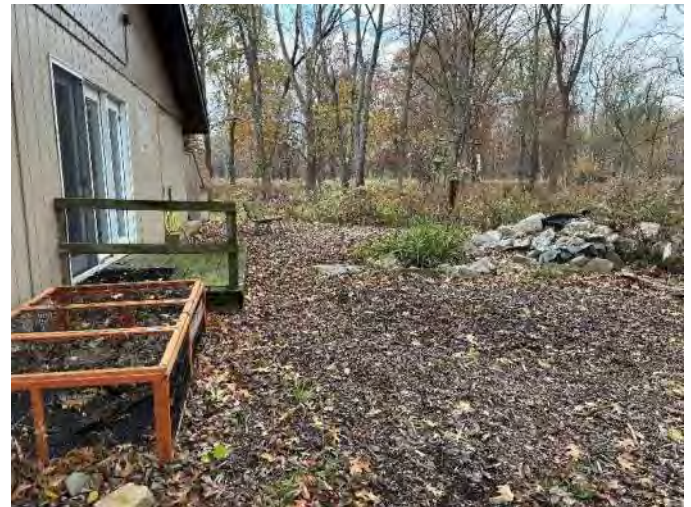
The north side of the building offers excellent view into the woodland and savanna to the north. The access to this area, and its seating and exhibits, however, lack formal walks and ADA accessibility from the site and the building.

FIGURE 4.1.2: North side of the nature center. Water feature is non-functioning

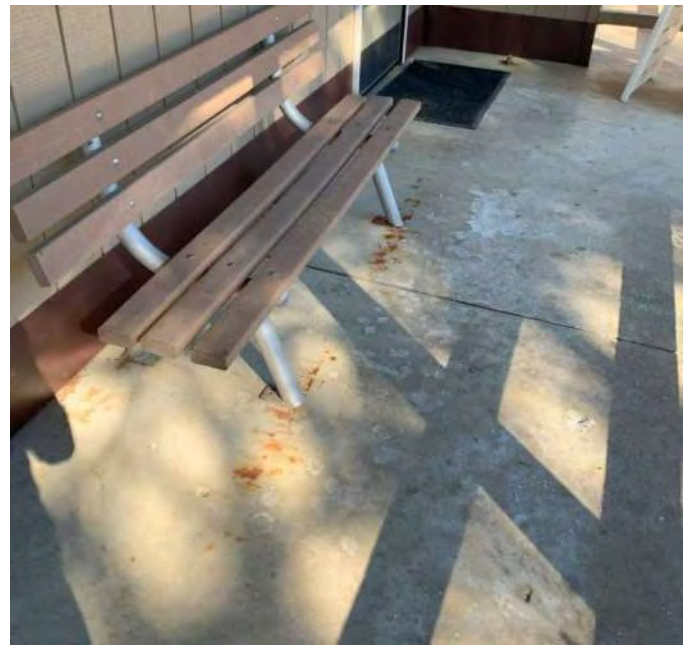
FIGURE 4.3.2: Existing condition of concrete at south entry

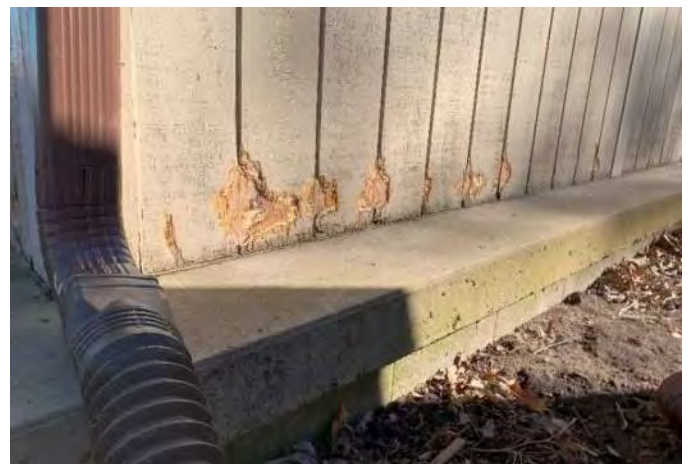
The existing exterior walls consist of 2x4 wood studs, fiberglass batt insulation in the cavity, and wood siding on wood sheathing. No base of wall flashing was observed. The wood siding is in fair condition in general but does exhibit several areas of missing or deteriorated wood due to insects, woodpeckers, and/or moisture. See Figures 4.3.3 and 4.3.4. CCFP desires, and it is recommended, that new durable, low-maintenance siding be installed. It is assumed the wood studs and sheathing are in fair condition and can be retained. Under the Existing Building Code, existing cladding can be altered without adding wall insulation. If desired, continuous insulation could be added to improve energy performance. Existing exterior walls at the west workroom do not have insulation. The majority of these walls will become interior walls due to the addition. However, cavity insulation should be added where these walls remain facing exterior.

FIGURE 4.3.3: Wood siding deterioration at west side

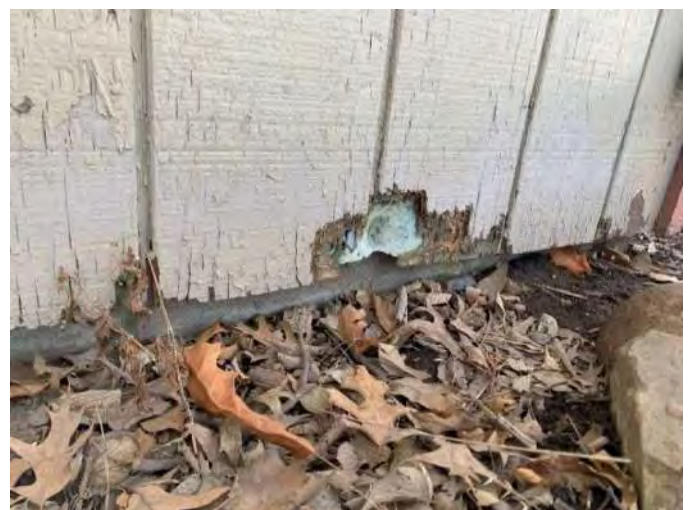
FIGURE 4.3.4: Wood siding deterioration at east side

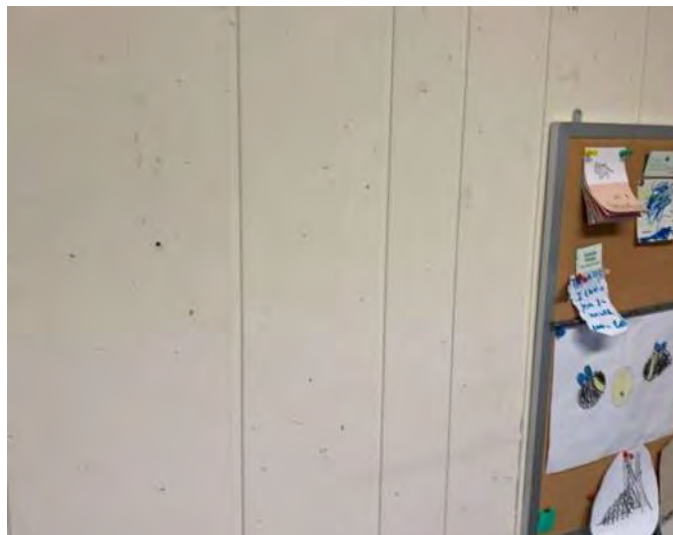
Interior walls are wood framed. The interior finishes at interior walls and the interior face of exterior walls vary. At restrooms, this is white laminate panels, in good condition. The exhibit space has softwood plywood paneling, while other spaces have vertical wood paneling in various finishes. Gypsum board, where occurring, is in good condition. Interior wood finishes appear in good to fair condition with some scuffing and wear consistent with its age. See Figure 4.3.5.

FIGURE 4.3.5: Interior wood paneling at Open Office

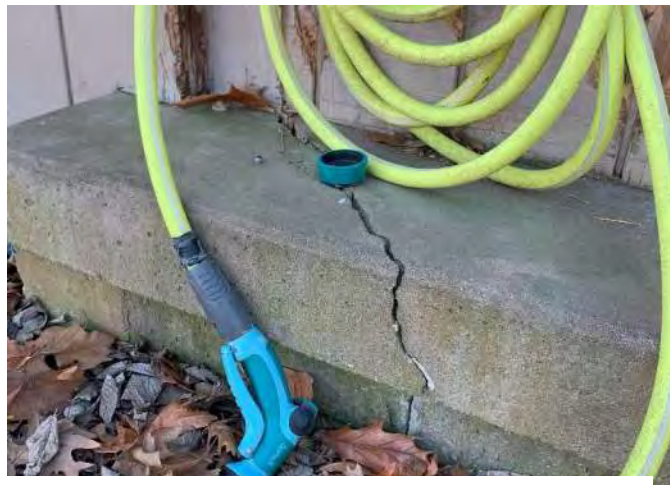
miscellaneous storage, is a slab on grade with typical concrete foundation walls. The concrete slab extends several inches past the exterior wall face, resulting in the exposed slab edge, see Figure 4.2.6. This slab is about  $\frac{3}{4}$ " lower than the rest of the building, see section 4.4 Accessibility. The slab and foundation wall appear in good condition with minor surface cracking. A larger crack at the north side (see Figure 4.3.6) should be monitored.

FIGURE 4.3.6: Cracking at slab/foundation wall, NW corner

The addition is proposed to be a slab on grade, with conventional strip footings and foundation walls down to the frost line, with code compliant insulation installed. The existing crawlspace can remain, along with all elements of the existing foundation. Cracks in the existing foundation should be monitored, but do not appear to be causing issue.

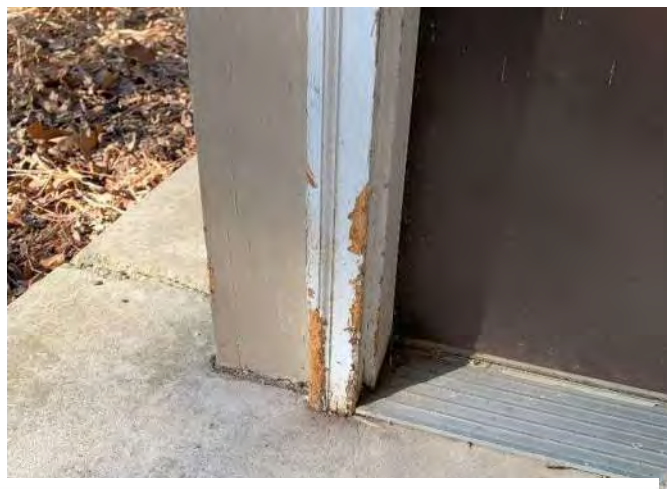
There are 3 exterior doors to the building, including the wood patio exit door. The main entry, and workroom exit door, are painted hollow metal. Interior doors are typically wood with wood frames. Interior doors are in fair condition with some paint chipping and minor abrasions. Exterior wood frames have paint damage and some deterioration, see Figure 4.3.7.

FIGURE 4.3.7: Wood trim damage at Workroom entry

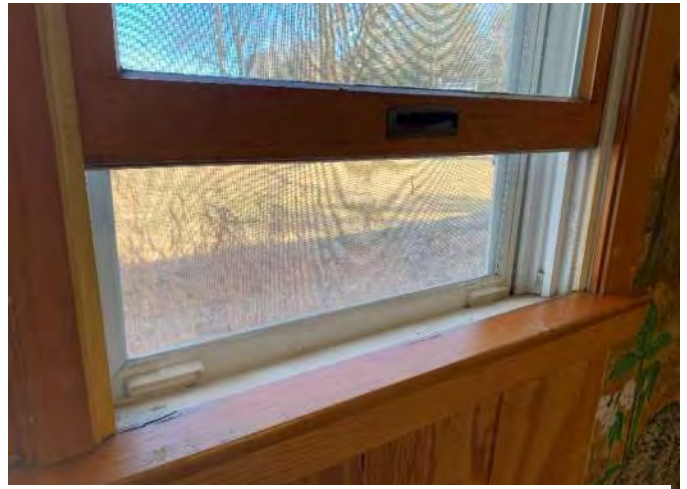
Windows in the main building are wood clad vinyl frames, with storm window present at operable locations. Refer to Figure 4.3.8. Glazing is single pane, including single pane picture (fixed) windows. Window operation varies, many are single-hung while others are awning or sliding operation. Insect screens are present. Windows in the west Workroom addition are double pane, fiberglass slider windows. Exterior window trim is in fair condition, with wear consistent with its age. Interior window trim exhibits knicks and scuffs consistent with its age. Some windows are anticipated to be removed or infilled due to the addition.

**FIGURE 4.3.8:** Window at exhibit space interior

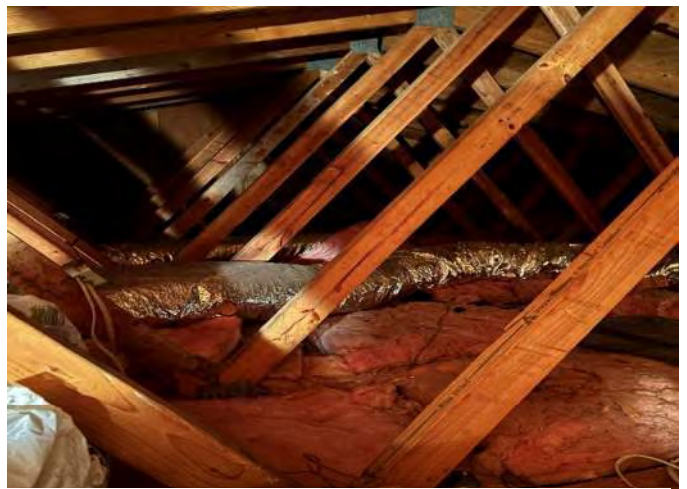
There is a continuous ridge vent, and vinyl soffit vents are present. The wood roof deck and structure appear in good condition. Existing 2x4 bottom chord trusses have batt insulation in between them, with 3" to 6" of insulation present. This results in well below current energy code standards of R-49 insulation for wood framed attic spaces. However, given the IEBC Alteration Level 3 (refer to code compliance section

**FIGURE 4.3.9:** Wood trusses and insulation at attic

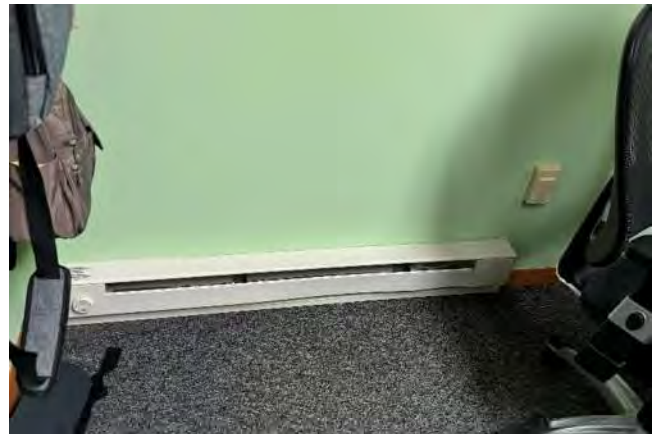
There are supplemental electric baseboard heaters with integral thermostats along the outside walls in several rooms. See Figure 4.4.1.

FIGURE 4.4.1: Baseboard heat at office

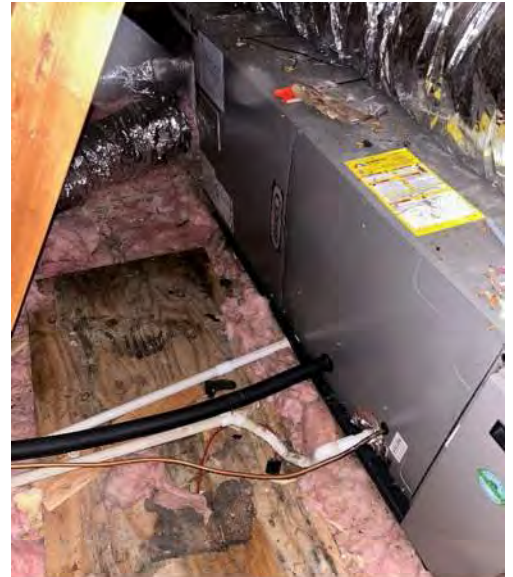
The ductwork was recently insulated, and the heat pump was recently replaced. The heat pump uses R-410A refrigerant, production of which will be phased out in the next several years due to its effects to the ozone. There are ceiling toilet exhaust fans which are vented through roof caps.

FIGURE 4.4.2: Attic Unit

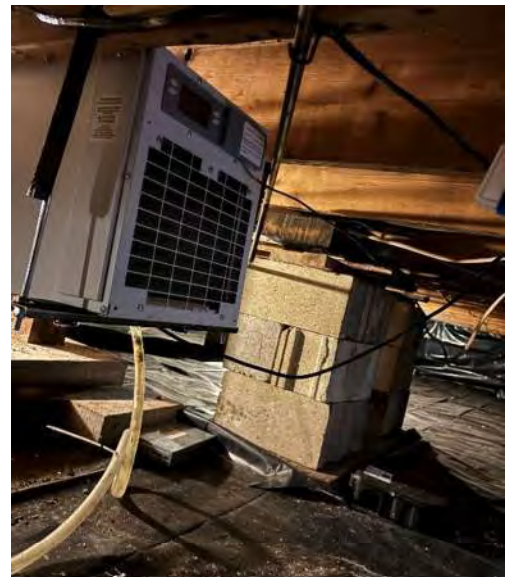
There is an existing de-humidification unit in the crawlspace. No moisture issues for the crawlspace were observed or reported, this unit can remain.

FIGURE 4.4.3: Crawlspace de-humidification

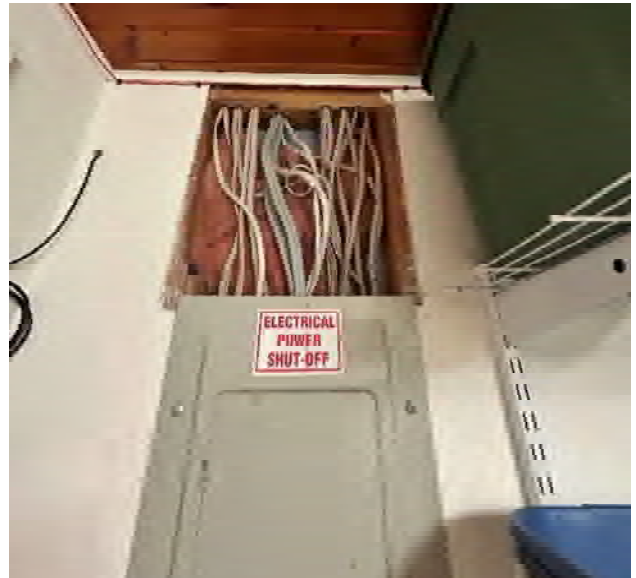
There is an electrical panel just opposite the meter in the utility room. Romex wiring is used throughout the building for wiring lighting, receptacles and equipment.

FIGURE 4.4.4: Existing panelboard and Romex wiring

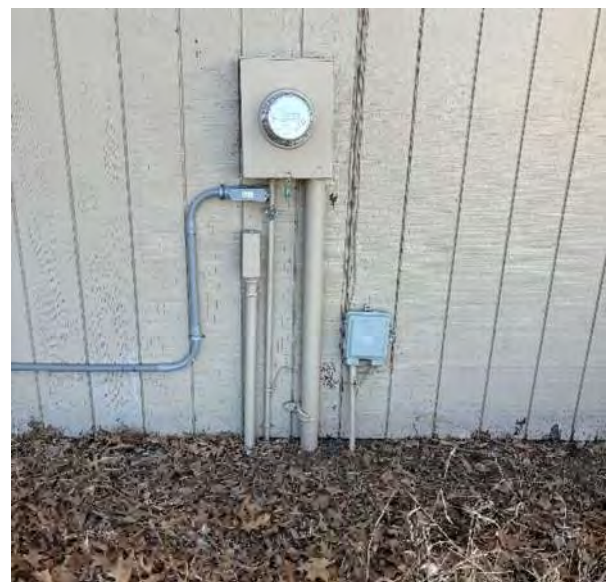
There is a 200 amp underground electrical service from the utility power pole near the road to the electric meter mounted on the east exterior wall.

FIGURE 4.4.5: Electric meter mounted on building's east side

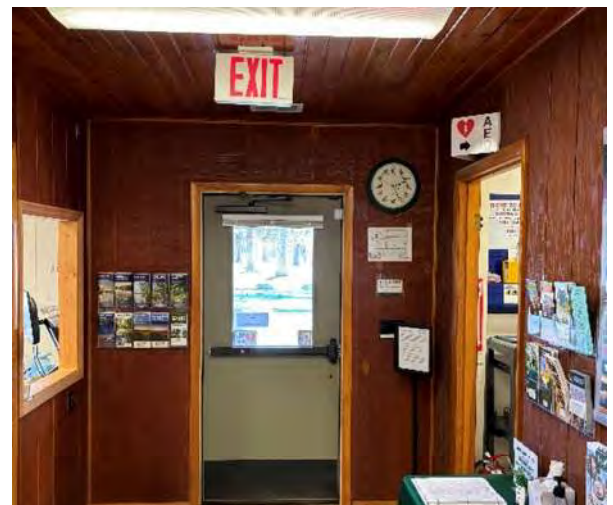
FIGURE 4.4.6: Emergency exit sign and typical surface mounted light

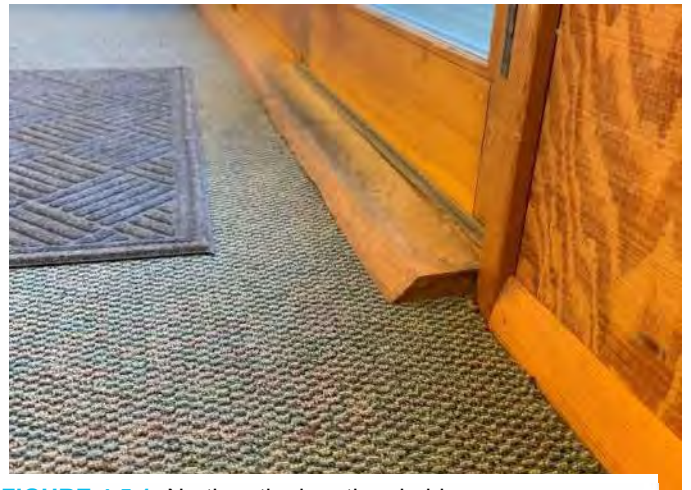
FIGURE 4.5.1: North patio door threshold

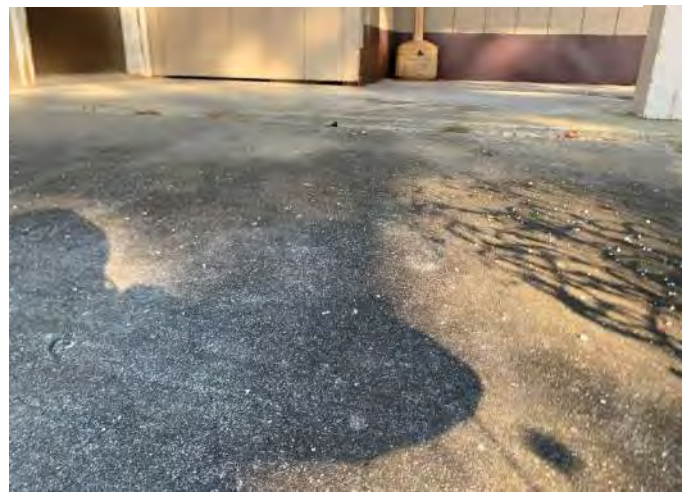
A concrete sidewalk from the west currently connects to the south porch. There is a transition of approximately 1" here, which does not meet the  $\frac{3}{4}$ " max. beveled transition requirement for an accessible pathway, see Figure 4.4.3. A new accessible path is proposed leading to the new front door of the addition. The new path can align with the existing slab, correcting this condition.

FIGURE 4.5.2: Porch transition at west side

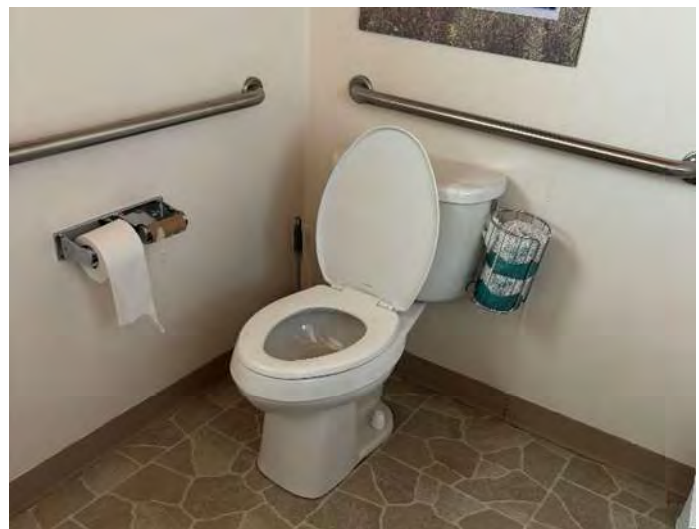
There are two existing restrooms, labeled as men's and women's with accessibility signage. While the men's restroom is very close, neither restroom fully meets current accessibility standards. At the women's restroom, toilet partition layout does not allow an accessible door approach or turn around space. The restrooms are proposed to be brought up to ADA standards without moving plumbing walls, see proposed plan.

The current plumbing fixtures and grab bars appear to meet accessible mounting locations. The flush valve of the women's water closet is on the wall side, which

FIGURE 4.5.3: Women's water closet
